THE  
ECCLESIASTICAL  
ARCHITECTURE  
OF SCOTLAND

FROM THE EARLIEST CHRISTIAN TIMES TO THE  
SEVENTEENTH CENTURY

BY  
DAVID MACGIBBON AND THOMAS ROSS  
AUTHORS OF "THE CASTELLATED AND DOMESTIC ARCHITECTURE OF SCOTLAND"

VOLUME ONE

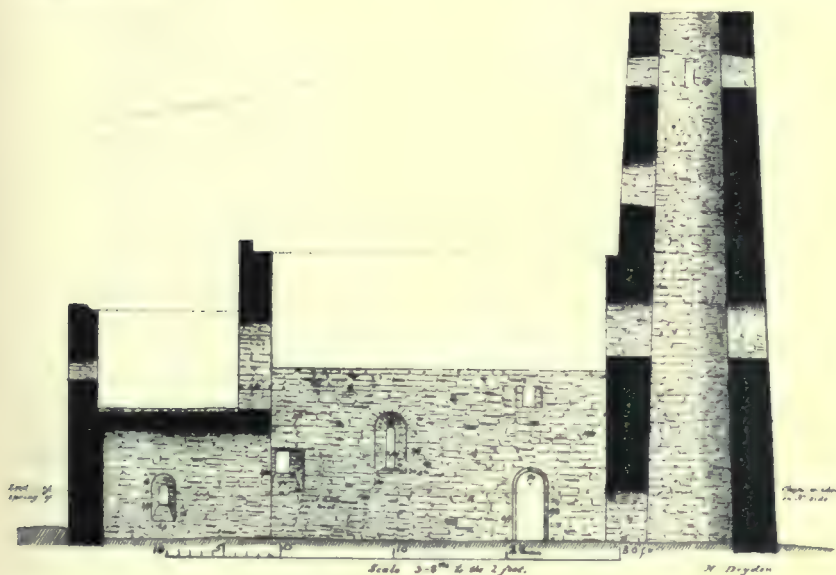
FIG. 99.—Church on Egilsay. Section from East to West.

heads and rebated jambs without chamfers. On the north side of the nave is a window 3 feet 3 inches high and  $8\frac{1}{2}$  inches wide at the outside of the wall with semicircular head. (Figs. 98-100.) The jambs are splayed inwards to 2 feet 9 inches wide. On the south is a similar window. It is to be observed that these windows have no external chamfer—that is, the outer edges of the jambs are acute angles. This peculiarity is found in early Irish churches.\* They were not originally glazed, but probably had a frame fitted into them, when required, covered with parchment. On this south side are two windows, not original—one close to the east wall and low down, the other high up over the south doorway. (see Fig. 102.)

On the south side, and near the ground, is a window, but this is a modern work. There is a small window in the second story looking north. (See Fig. 99.)

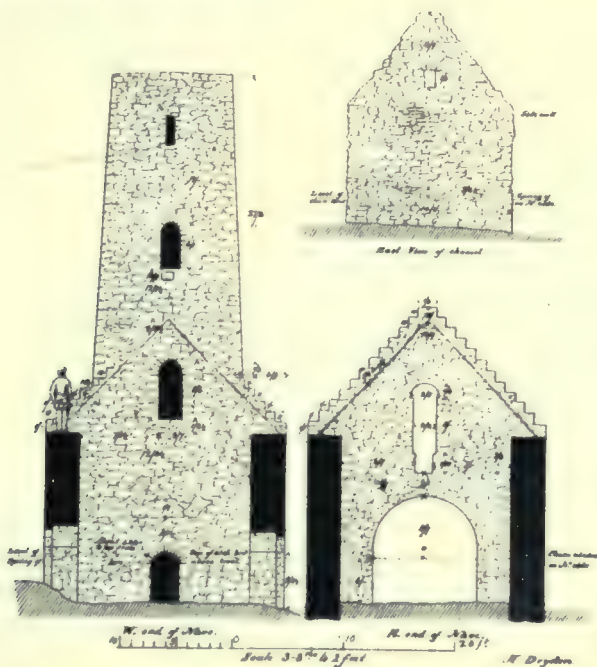
FIG. 101.—Church on Egilsey. West and East Elevations.

On the west of the nave is the tower, which is circular, 14 feet 10½ inches diameter externally, and 7 feet 8 inches diameter internally. An arch 2 feet 5 inches wide leads from the nave into it. (Fig. 101.) The jambs are 3 feet 7 inches thick, and the head is semicircular. The tower appears to have been built with the nave, although the stones in the tower are on the average smaller than those in the nave, which difference may be accounted for by the unfitness of large stones, when not freestone, for circular work.

The chancel is 14 feet 11 inches by 9 feet 5½ inches inside; the side walls 2 feet 9 inches thick, and the east wall about the same. It is roofed with a plain barrel vault, of which the semicircular chancel arch forms part. (See Fig. 101.) The impost of this arch is 5 feet from the floor of the nave. Probably there was a step here or a little farther east.

Over the vault of the chancel is a chamber, entered from the nave by a semicircular arch 6 feet 4 inches high and 2 feet 2 inches wide, over the chancel arch. (See Fig. 101.)

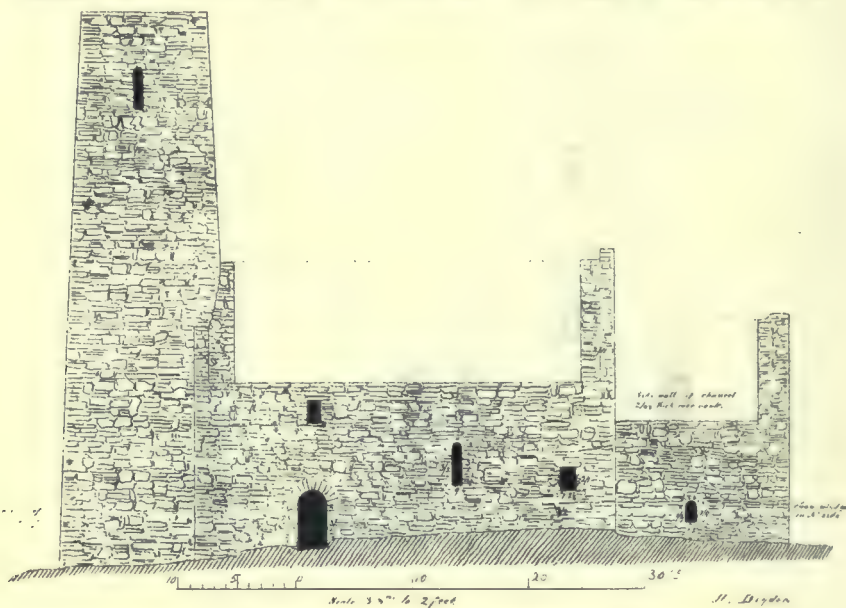
FIG. 102.—Church on Egilsey. South Elevation.

1 inch in width, without an external chamfer. On the south is a similar window. (Fig. 102.) Probably, like the nave windows, they were not originally glazed.

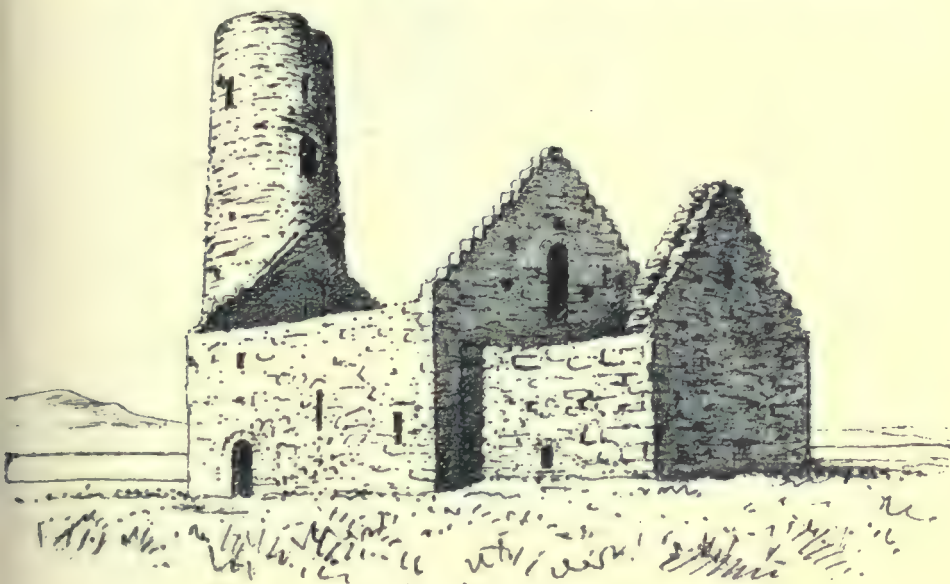
FIG. 103.—Church on Egilsey.

The ridge of the chancel roof was 20 feet 9 inches above the floor of the nave. [Figs. 103, 104 show the appearance of the building from south-east and north-west.]

The style of architecture (Figs. 103, 104) (discarding certain indications of an earlier date) prevents our assigning to it a later date than the beginning of the twelfth century. When we contrast it with the Kirkwall Cathedral, begun in 1137, we are forced to give an earlier date than that to Egilsey. This opinion is corroborated by the churches at Orphir and the Brough of Birsay. The islands were conquered by the Norsemen in 876, and reconverted to Christianity in 998. The church, therefore, was probably not built between those dates. There were Christians in these islands before the arrival of the Norsemen. The name of the island, as

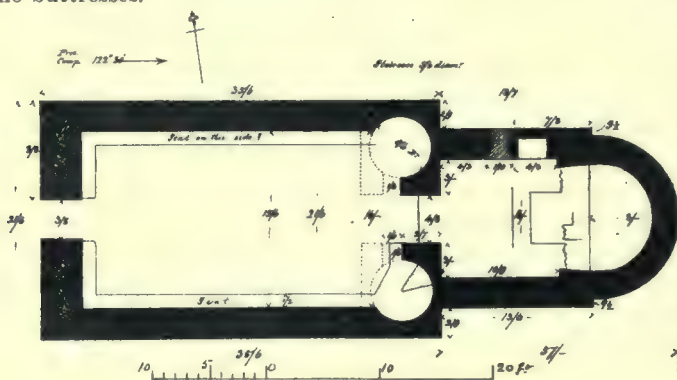
FIG. 106.—Church on Brough of Birsay. Plan.

apse, all well defined, and all apparently built at the same time. (Fig. 106.) The material is grey whinstone, and no traces of freestone dressings appear. It stands nearly east and west, but the west end facing a little to the north of west.

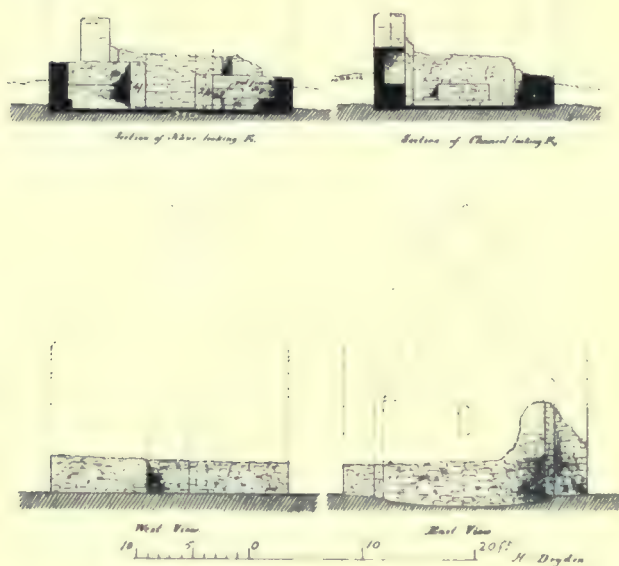
FIG. 107.—Church on Brough of Birsay. East and West Elevations and Sections.

The interior is filled with debris to the depth of about 2 feet 6 inches above the floor, and the exterior to about the same depth. Partial excavations were made for this plan. Of the west end, only 3 feet in height of wall remains (Fig. 107); of the north wall (Fig. 108) a little more, and of south wall a little less; of the north wall of chancel, 8 feet 6 inches; of south wall of chancel, about 2 feet; of the apse, about 2 feet 4 inches. The nave is 28 feet 3 inches by 15 feet 6 inches, inside.

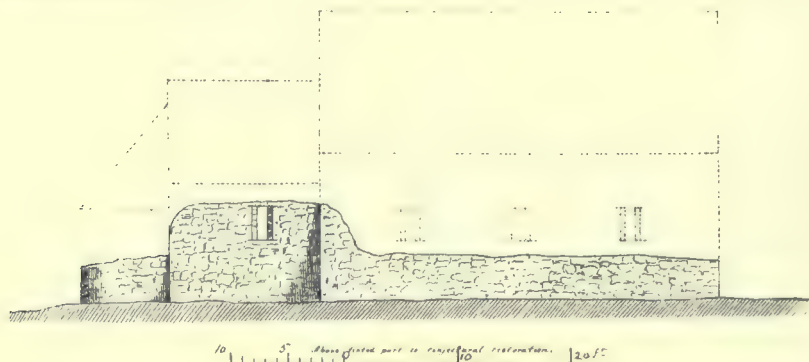
FIG. 108.—Church on Brough of Birsay. North Side Elevation.

In the north-east and south-east corners are two circular spaces 5 feet 6 inches in diameter (see Fig. 108), the south one of which contains a freestone stair step, and the north one some broken stone. Probably both were staircases; but how high they reached, to what they led, and what was the superstructure we can only conjecture. One or both may have led to turrets, or to priests' rooms over the chancel arch, or chancel or nave. We cannot suppose a rood-loft to have existed here. The support of the west side of the stairs is now gone, but we must suppose that a block of masonry existed which included the circle of the staircase. Against this, the *seat* on the south apparently runs past the spot at which it should have stood, and there are no decisive traces of a junction in the north and south walls. There is no other solution of the difficulty. This very massive separation between nave and chancel is probably unique. M'Cormac's chapel at Cashel has a turret and a chamber in nearly the same positions as these staircases; but the construction in that case is clear.\*

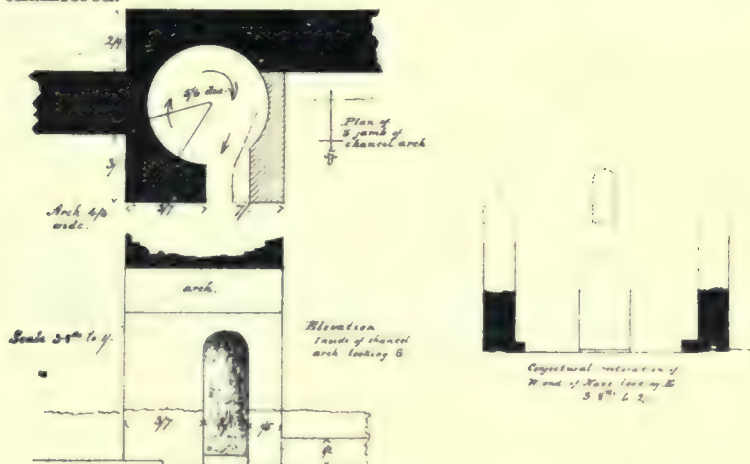
FIG. 109.—Church on Brough of Birsay. Entrance to Chancel, and Interior Elevation of West End.

The entrance to the chancel is 4 feet 3 inches wide, of which 4 feet in height of the jambs remain. They are 3 feet 7 inches thick from west to east, but if the construction was that suggested above, the jambs were 7 feet from west to east, including an entrance into each turret 2 feet wide. (Fig. 109.) The entrance to the chancel was probably surmounted by a semicircular arch of whinstone, plastered, about 8 feet or 9 feet high to the apex, with string-course caps 4 or 5 inches deep. The angles were not chamfered.

There is a step in this entrance of only 2 inches, and from that to the east end of the apse was flush originally. The pavement is of flagstones. This low position of the original altar is peculiar.

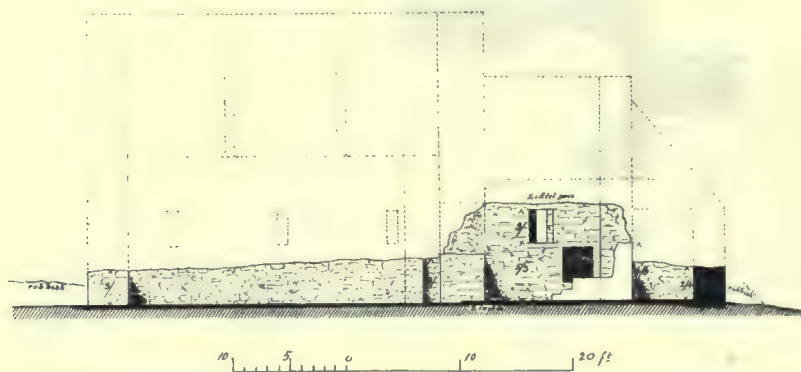
FIG. 110.—Church on Brough of Birsay. Section from West to East.

The chancel is 10 feet 9 inches east and west, and 10 feet 3 inches inside. Only one window remains, which is in the north wall of chancel, and this has lost its lintel (Fig. 110). The clear opening was 3 feet by 10½ inches, with, as stated, a square head. The window has an internal and external splay, each widening to 1 foot 10½ inches. This form is peculiar. There was probably a frame, fixed in the narrow part of the opening, containing glass. In this wall, just east of the window and lower, is a square ambry, 3 feet high by 2 feet 8 inches wide, and 1 foot 11 inches in recess. The use of so large an ambry is not evident. The bottom of it is only 2 feet above the floor. There is no appearance of its having had doors. In the north-east part of the nave of Enhallow Chapel is a similar recess, and one in the same position as this in the chapel on the Brough of Deerness. It is possible, but not probable, that these were

It is remarkable that the floor was originally level to the end of the apse, and no elevation given to the altar, which was probably at the chord of the apse; but in later times they built a reredos which *blocked off* the apse, and then they appear to have made steps to the altar. Some part of the altar remains. It appears to have been 4 feet 1 inch by 2 feet 7 inches. Possibly the reredos did not reach many feet high, so that the upper part of the apse appeared over it.

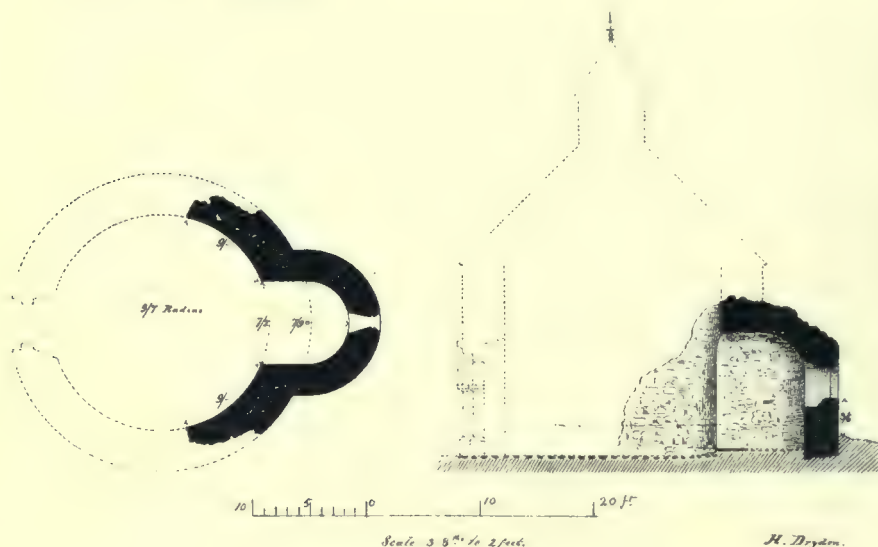
FIG. 111.—Church at Orphir. Plan and Section through Apse.

The chancel, which is little more than the apse, is 7 feet 2 inches wide and 7 feet 9 inches deep, or long, with wall 2 feet 8 inches thick. The arch into it is semicircular, and forms part of a plain unribbed vault, as at St. Margaret's Chapel at Edinburgh. (See Fig. 111.) The impost of the vault arch is 6 feet 5 inches above what appears to have been the floor, and the top, consequently, 10 feet 6 inches high. Outside the vault was originally probably a solid stone roof, the apex of which was about 14 feet

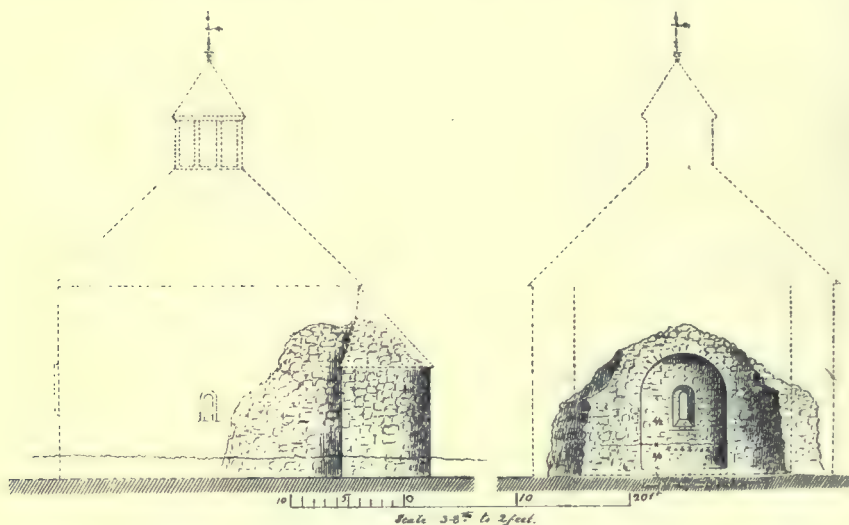
FIG. 113.—Church at Orphir. Elevations of Apse.

from the floor. This height (supposing also that there was a step at the chancel arch) would oblige the walls of the nave to be about 15 feet high. The chancel has no buttresses. There is one window in the chancel, in the east end, 2 feet 5 inches by 10½ inches clear, opening with jambs splayed inward to 1 foot 8 inches wide. (Fig. 113.) The outer edges are chamfered, and the head semicircular. The impost is at the same level as of vault. It has a groove for glass.

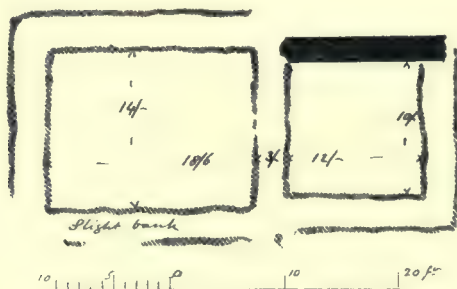
FIG. 114.—Chapel of Noss. Plan.

It consisted of a nave and chancel (Fig. 114), of which only a frag-

ment of the north wall of the chancel remains, about 4 feet or 5 feet high. The nave was about 18 feet 6 inches by 14 feet, and the chancel about

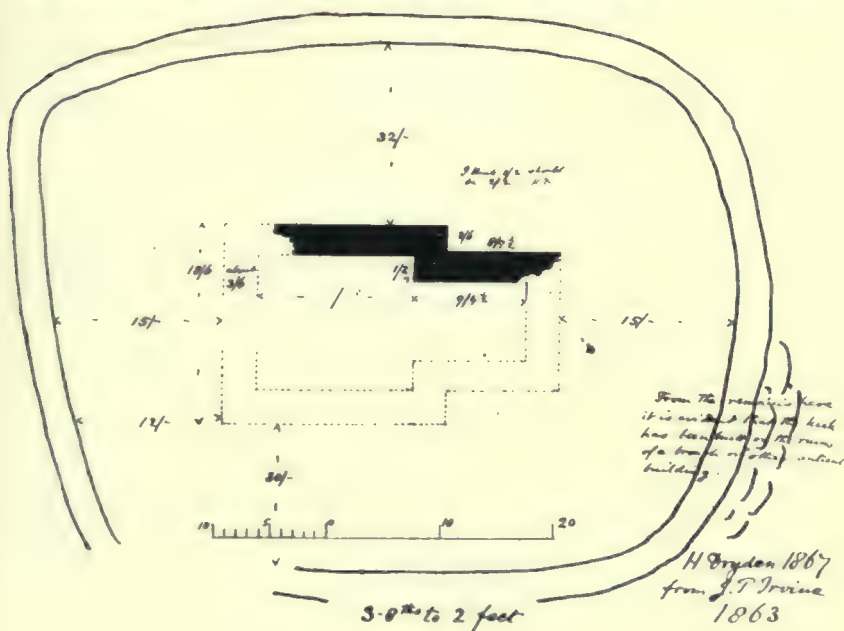
FIG. 115.—Kirkaby, Westing. Plan.

built on the ruins of a brough or other ancient building. The dedication is unknown. The church consisted of a nave (Fig. 115) about 13 feet 9 inches by 12 feet, and a chancel about 10 feet by 7 feet inside. The walls were about 2 feet 9 inches thick. The chancel arch was equal in width to the chancel. About 2 feet in height of the north wall of the nave and of the north wall of the chancel remains, and traces of the rest sufficient to approximate to the size. The entrance was probably in the west end. The chancel inside equals in length the diagonal of the square of the width.

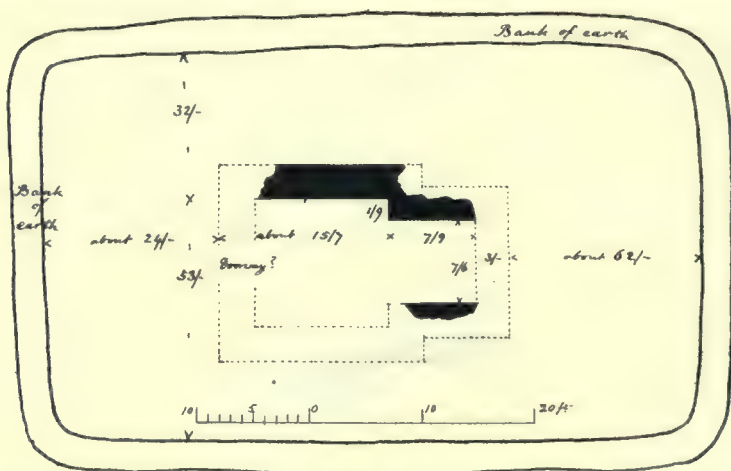
FIG. 116.—Meal Colvidale. Plan.

This is in the south-east part of the island, in a yard about 112 feet east and west by 85 feet north and south. (Fig. 116.) The dedication is unknown. The nave is about 12 feet by 11 feet inside; the chancel 7 feet 9 inches by 7 feet 6 inches inside; and the walls 3 feet thick.

About 2 feet in height of the north wall of the nave, and about the same of the north wall of the chancel, and a fragment of the interior face of the south wall of the chancel remain. Traces indicate the outline. The nave is very short. The chancel arch was equal in width to the chancel. The door was probably in the west end.

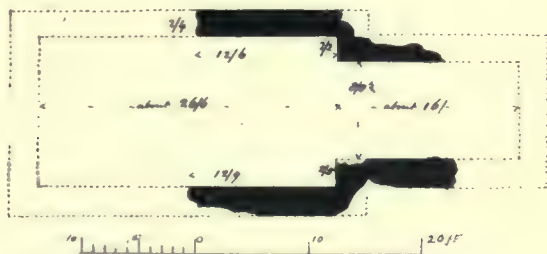
FIG. 117.—St. John's Kirk, Norwick. Plan.

It consists of nave (Fig. 117), about 26 feet 6 inches and 13 feet 6 inches inside, and chancel about 16 feet by 8 feet 8 inches. The walls are 2 feet 4 inches thick. Only about 2 feet in height of the central portion remains, that is about 12 feet 6 inches of the east part of the nave, and about 10 feet of the west part of the chancel. The chancel arch was equal in width to the chancel. The doorway was probably in the west end.

inside to double its width. Chancel equal inside to vesica piscis.

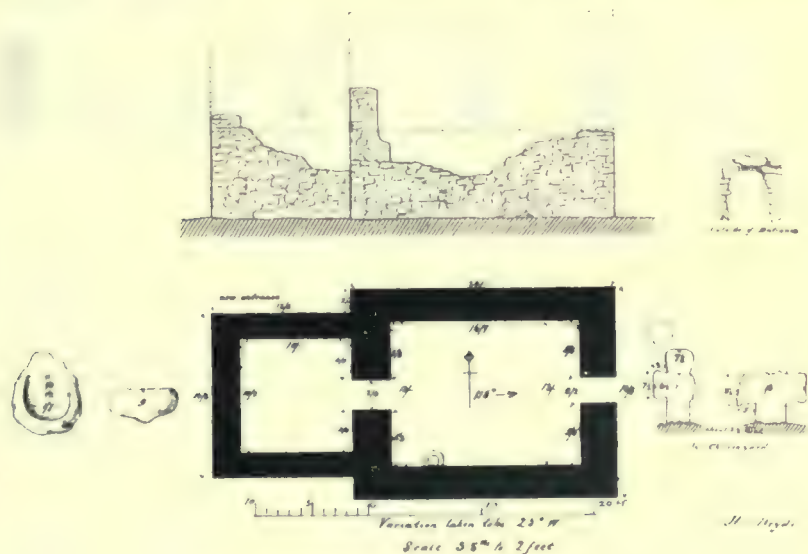
FIG. 118.—Church at Uya. Plan, South Elevation, &c.

It consists of a nave and a building like a chancel to the west of the nave (Fig. 118), and lies true east and west.

The nave is 16 feet 9 inches by 13 feet inside. The east wall of the nave is 3 feet 6 inches thick, and the others now vary from 2 feet 10 inches to 3 feet 1 inch. The side walls vary from 6 feet to 7 feet 6 inches in height. No window remains, but probably there was one on the south side.

near the west end of it, is a rough stone stoup built into the wall. (See Fig. 118.)

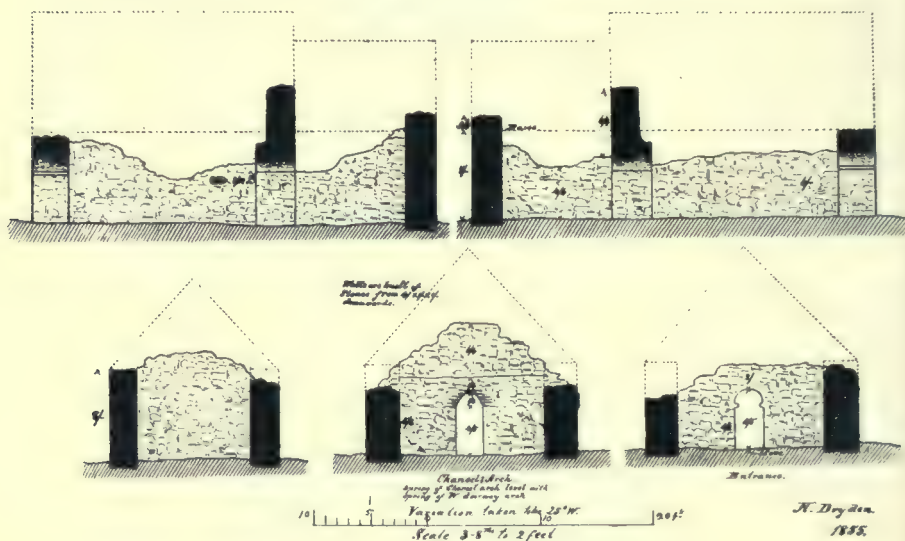
FIG. 119.—Church at Uya. Elevations and Sections.

In the east end is an arch or doorway (Fig. 119), 2 feet 2 inches wide, with parallel unrebated jambs, and a semicircular head of one rectangular

order, with simple un moulded projections for caps. The arch is formed by overlapping the stones as in the cells of broughs. At the west end is an opening 2 feet 6 inches wide, of similar character, except having a ruder arch and no caps. Above this arch, 6 feet 4 inches in height of the gable remains. Through this is the west apartment, resembling a chancel, which is 10 feet east and west by 10 feet 2 inches north and south, and has walls 2 feet 3 inches thick.

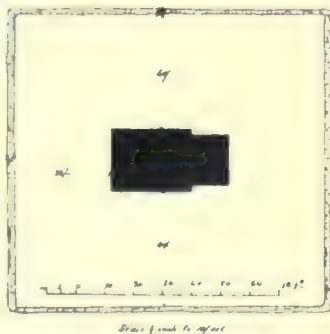
FIG. 120.—Kirk of Ness. Plan.

It is the most complete of the old churches of Shetland, and is said to have been dedicated to Olave or Olaf, the great warrior saint of the North. It is enclosed in a walled yard about 110 feet by 100 feet. (Fig. 120.)

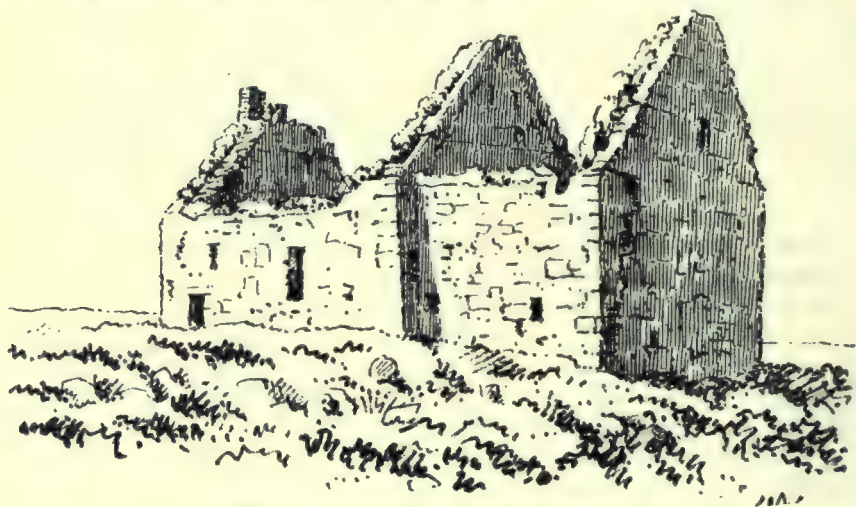
FIG. 121.—Kirk of Ness. View from South-East.

It consists of nave and chancel, with bell-cot on the west gable, and lies nearly true east and west. The roof is gone, but the church was used down to 1750. (Fig. 121.)

The material is the grey stone of the district, placed at random, some of the blocks being very large, and the interstices filled with small stones.

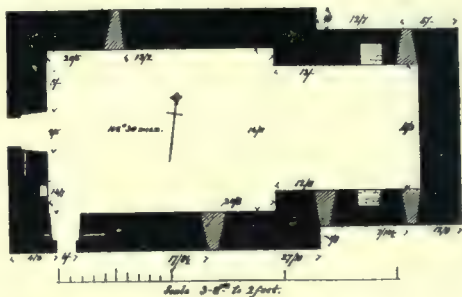
FIG. 122.—Kirk of Ness. Plan.

The nave is 20 feet 5 inches by 14 feet 10 inches inside. (Fig. 122.) The west end is 3 feet 6 inches or 3 feet 8 inches thick; the north and south walls about 3 feet 3 inches. The side walls are 11 feet 10 inches or 12 feet high from the floor. In the west end is a square-headed door-

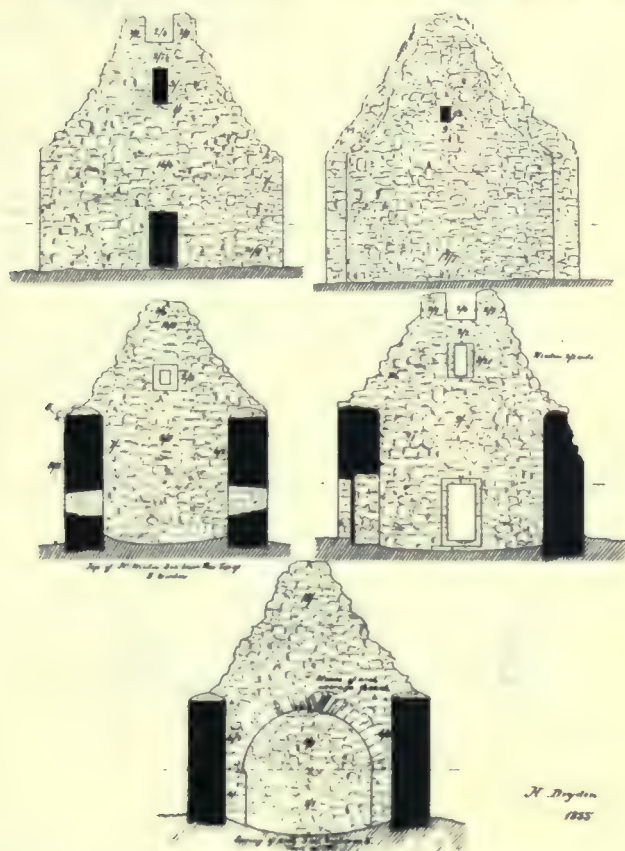
FIG. 123.—Kirk of Ness. East and West Walls and Chancel Arch.

way, 2 feet 7 inches wide and 5 feet 4 inches high externally, with rectangular jambs rebated for a door. (Fig. 123.) The interior width is 3 feet 5 inches. The internal head is also square. Holes for the insertion of a wooden bar for securing the door remain in the north and south jambs. In the south wall, and close to the west end of it, is another square-headed doorway, externally 1 foot 9 inches wide, and 5 feet 9 inches high, with internal head square as of west doorway, and bar-holes as before. (Fig. 124.) In the north wall is a square-headed window, of which the west side and the top are gone, owing to the west portion of the north wall having fallen down. This window is nearer the west than the east angle of the nave. In the south wall (Fig. 125) is a square-headed window, 3 feet by 1 foot 1 inch externally, splayed inwards to 3 feet 4 inches by 2 feet 2 inches. The external angles of the jambs are not chamfered, nor are there grooves or rebates

doorway (inside) is a square-headed window (see Fig. 123), 3 feet by 1 foot 1 inch externally, splayed inward to 3 feet 2 inches by 2 feet 3 inches. At 2 feet 2 inches above this (outside) is another opening, 2 feet 4 inches wide, for a bell. The west face of the bell-cot is 7 feet 10 inches wide. The top is gone, but about 2 feet 3 inches in height of the jambs remain. The jambs are parallel both ways, and about 1 foot 6 inches thick from east to west. The ridge of the roof was about 3 feet higher than the bottom of the opening for the bell, and whether this opening

The chancel is 13 feet by 11 feet 3 inches inside. The north and south walls are 3 feet 2 inches, and the east one 3 feet 6 inches thick. The chancel arch (Figs. 123 and 126) has no projecting jambs, but springs from

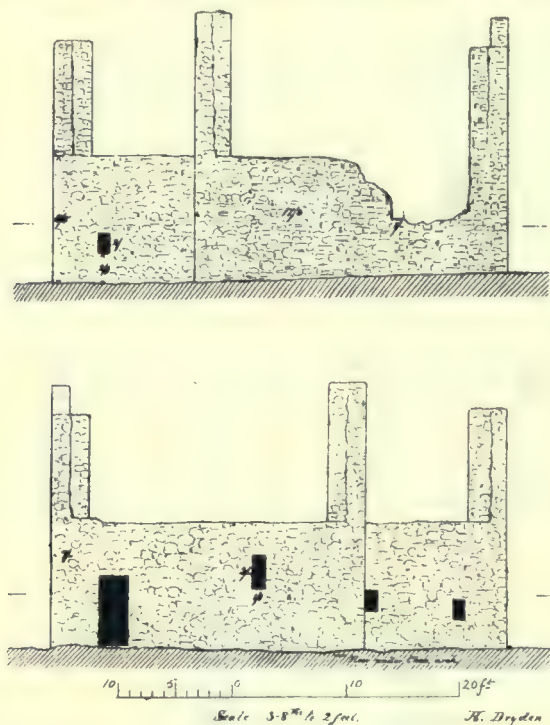
FIG. 124.—Kirk of Ness. North and South Elevations.

wall, exactly opposite this window, is a similar one, 1 foot 7 inches by 1 foot. (See Figs. 124 and 125.) The top of the external opening of this window is 7 inches below the south impost of the chancel arch. The top of the window on the north is 3 inches lower than on the south—the same difference as in the two springs of the chancel arch. In the west angle of the nave and chancel is a similar window, 1 foot 9 inches

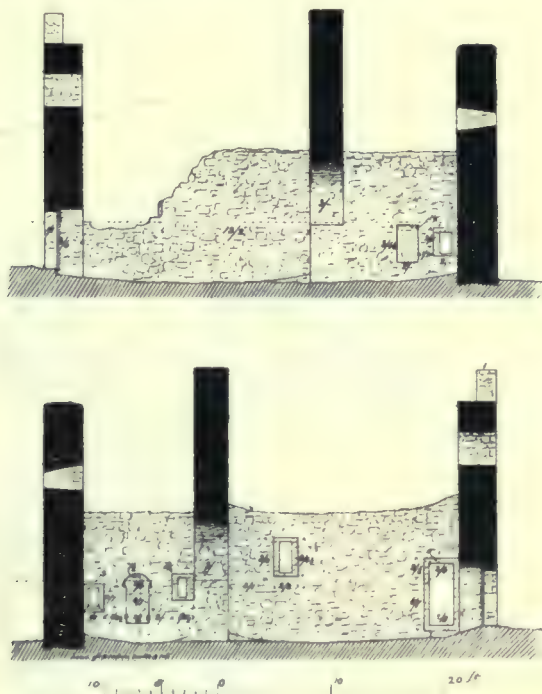
FIG. 125.—Kirk of Ness.

Between these two windows on the south is a sedile (see Fig. 125), 4 feet 7 inches high by 2 feet 1 inch wide, and 1 foot 8 inches deep, with a segmental head. The bottom is 1 foot 8 inches above the floor. It is evident that there was no step in the chancel, and no step at the altar.

On the north side, a little west of the window, is a square-headed recess (see Fig. 125), 3 feet  $4\frac{1}{2}$  inches by 2 feet, and 1 foot 11 inches recessed—probably an ambry, possibly an eastern sepulchre.

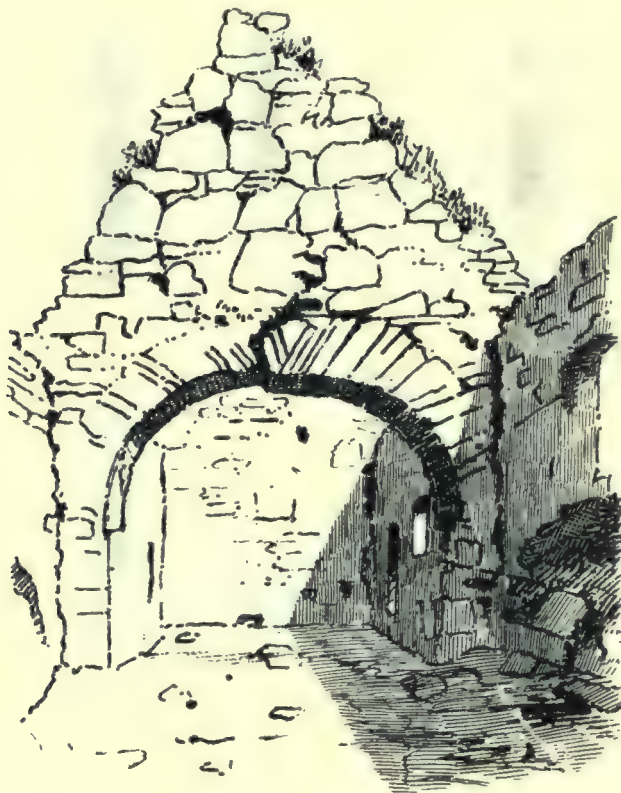
FIG. 126.—Kirk of Ness. View of Chancel Arch.

the chancel walls at 5 feet 7 inches above the floor, and the feet of the arch are set 3 inches back on the jambs at the impost, as at Wyre and Linton in Orkney. (See account of church on Brough of Birsay.) The spring is 3 inches higher on the south than on the north. There is no cap. The arch is semicircular, and consists of one rectangular order 3 feet thick. The stones of the arch average 1 foot 6 inches in length, but are thin. The top of the gable is 19 feet above the impost. The abutments of this arch were not sufficient, and the nave and chancel walls have spread, and a considerable fissure has taken place at the crown of the arch. In the north wall, at the east corner, is a square-headed window, 2 feet by 1 foot externally, splayed inward to 2 feet 5 inches by 2 feet. In the south

the peculiarity at the impost. The doors and windows are flat-headed. The former have rebates, which is not the primitive form, though Egilsey has them—the latter have the early form of jambs. Taking all the points, it may be assigned with probability to the fourteenth century.

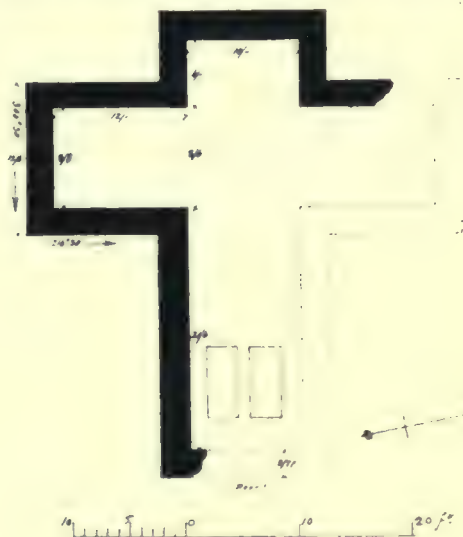
FIG. 127.—Church at Culbinstrough. Plan.

The dedication is not known. It originally consisted of a nave, north and south transepts, and chancel, and lies about west by north and east by south. (Fig. 127.) There remain now only the lower portion of the north transept, lower portions of the chancel, and a small fragment of the east wall of the south transept. It is built of the grey stone of the locality in rude courses of moderate-sized stones. On the north side of the nave, and at the west end, is a modern wall about 3 feet high, but as

this is on the foundation of the original north wall, it is probable that it marks the extent westward of the old nave. Assuming this, the nave was 21 feet 6 inches by 10 feet inside. The walls were probably 2 feet 3 inches thick. The position of the doorway is not evident, but probably was in the west end. Traces of the south wall remain. The north transept is 12 feet north and south by 8 feet 6 inches east and west inside. The north wall is 2 feet 3 inches thick, and the east and west walls 2 feet thick. The north end is 9 feet high, and retains the window, which is square-headed (Fig. 128), 1 foot 9 inches high, and 1 foot 3 inches

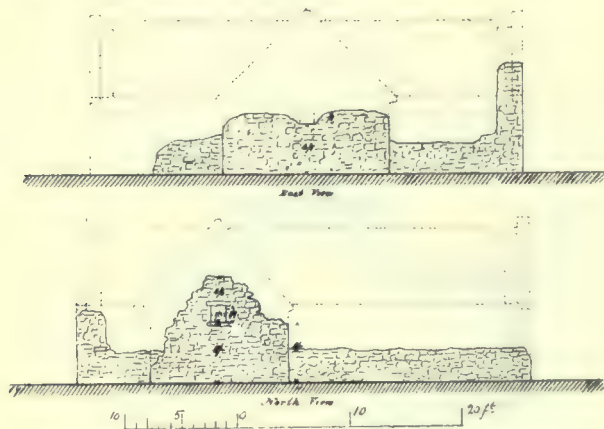
FIG. 128.—Church at Culbinsbrough. East and North Elevations.

wide outside. It is slightly splayed inwards. The sill is 5 feet above the present ground, but the original level of the floor has not been ascertained.

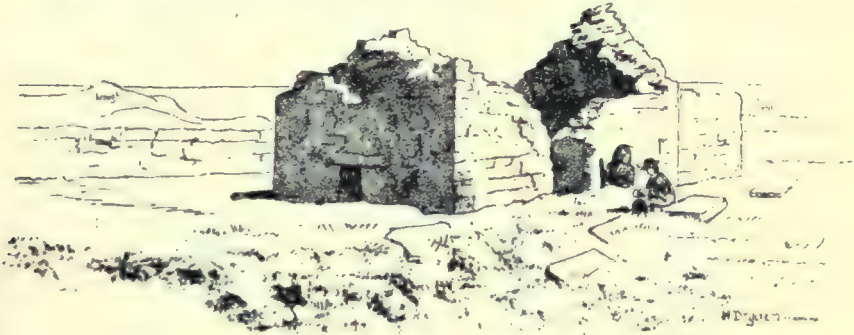
FIG. 129.—Chapel at Lybster. View from South-West.

This chapel (Fig. 129) was stated, in 1726, to be dedicated to St. Peter. It is described and illustrated by Muir in his *Ecclesiastical Sketch of Caithness and Orkney*, 1861. He states that it was dedicated to St. Mary.\*

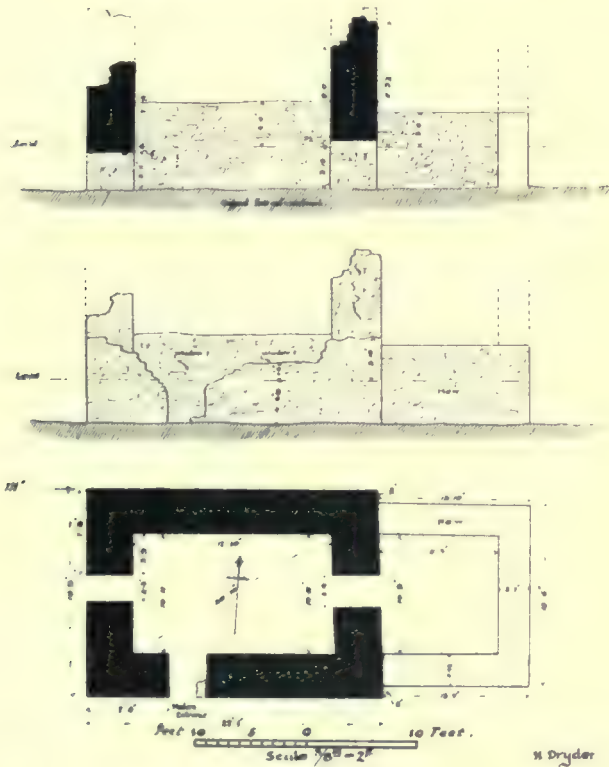
FIG. 130.—Chapel at Lybster. Plan, South Elevation and Section.

It consists of nave and chancel, both unroofed. (Fig. 130.) Muir, in his plan, places the chancel to the north of the nave, but it is in the usual position.

high above the present ground level, and is apparently about its original height. The south wall is partly broken. The west wall is 11 feet 8

inches, and the east wall 15 feet 2 inches above the present ground. The latter gable was about 1 foot 6 inches higher than at present, and the west gable, of course, level with it. I did not ascertain the original level of the floor, but it must have been at least a foot below the present ground, so that the total height of the gables was about 16 feet 2 inches.

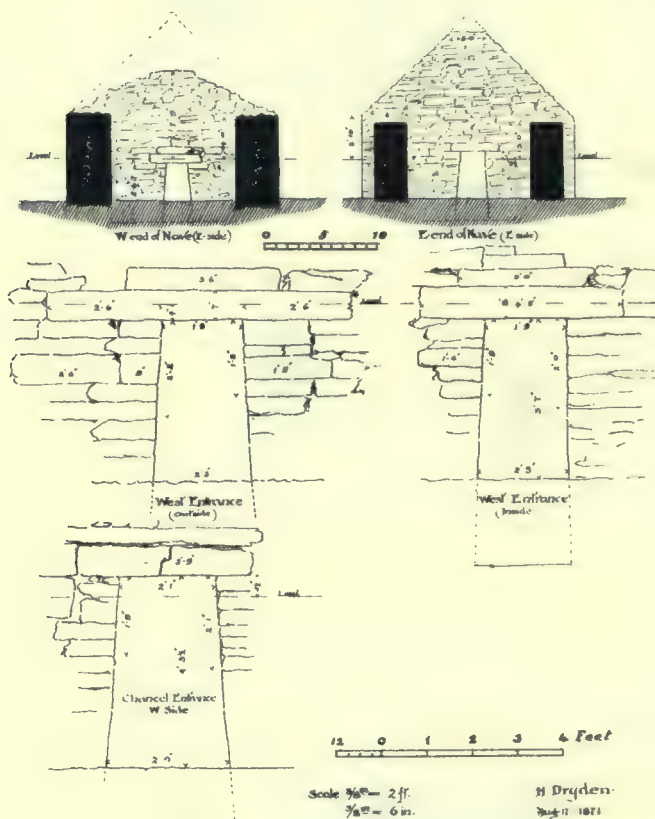
FIG. 131.—Chapel at Lybster. West End, Doorway, and Chancel Entrance.

In the west end (Fig. 131) is an entrance 2 feet 3 inches wide at bottom and 1 foot 9 inches at top. The head is horizontal; the jambs are parallel, and there is no sign of hinges for a door. The jambs are now 3 feet 11 inches high. The soffit of the head is flush between the outside and the inside. Another entrance has been made in the south wall near the west end, but the wall is broken here, and the form of the head is uncertain. There is now no trace of a window, but one may have existed in the place of this doorway.

The entrance to the chancel is 2 feet 9 inches wide at the bottom and 2 feet 1 inch at the head, which is flat, like the west entrance. The chancel is 11 feet 3 inches east and west, by 10 feet 9 inches north and south inside. The walls are 2 feet  $4\frac{1}{2}$  inches on the north and south and 2 feet 7 inches on the east. The walls are about 1 foot lower than the north wall of the nave. This chancel has been rebuilt, probably on the old foundation, and is used as a family burying-place.

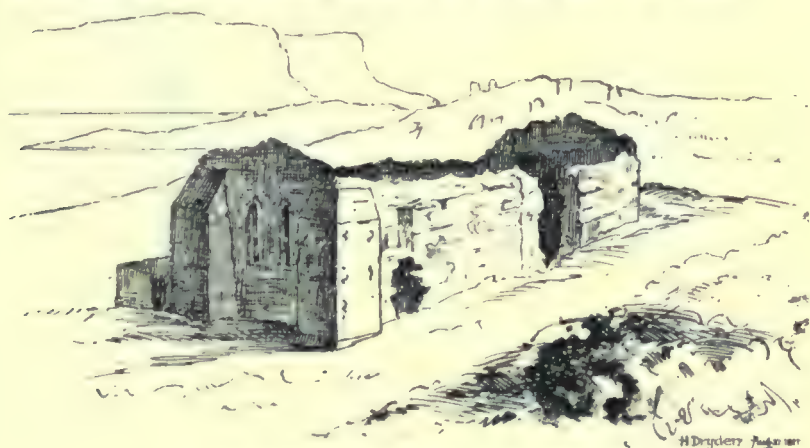
FIG. 132.—Chapel on Inch Kenneth. View from North-East.

The chapel (Fig. 132) adjoins the burial-ground, which is on the south-east part of the island, and at 50 or 60 feet above the water.

considerably ; and to obviate further decay, large clasping buttresses (see Fig. 132) were made at north-east and south-east angles, at some period much after the building of the chapel, but long ago.

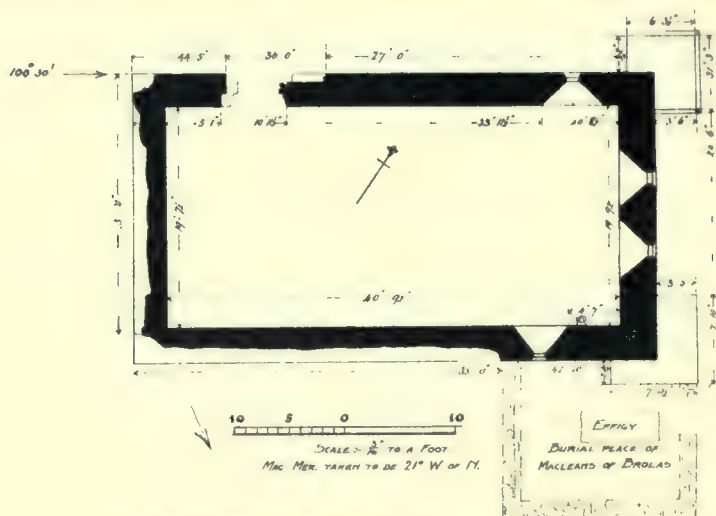
FIG. 133.—Chapel on Inch Kenneth. Plan.

The chapel (Fig. 133) is a plain parallelogram, 40 feet 9 inches east and west by 19 feet 8 inches north and south inside. It is deflected 10

degrees 30 minutes to the north of true east, assuming the magnetic meridian to be 21 degrees west of true north.

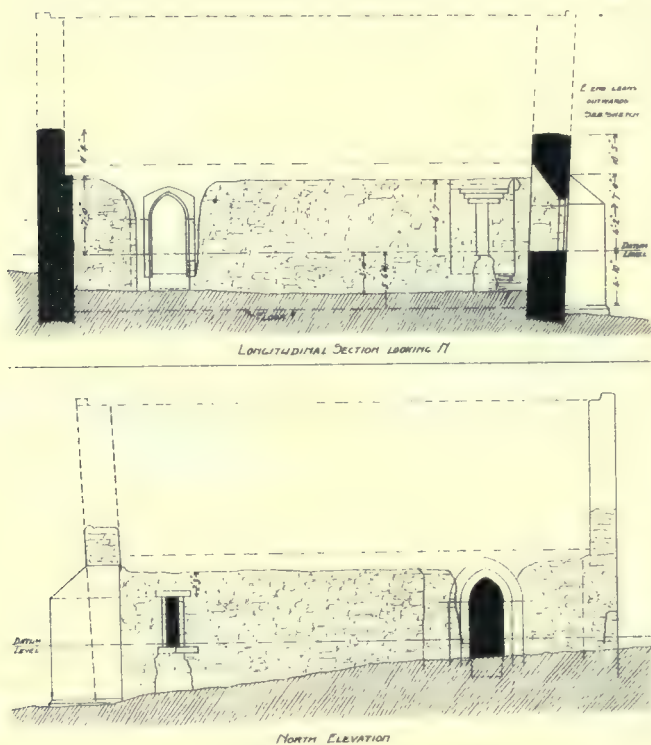
FIG. 134.—Chapel on Inch Kenneth. Section and North Elevation.

The doorway (Fig. 134) is in the north wall, near the west end, on the side sheltered by the hill; but all the freestone has been taken out, except two stones of the inner order of the east jamb.

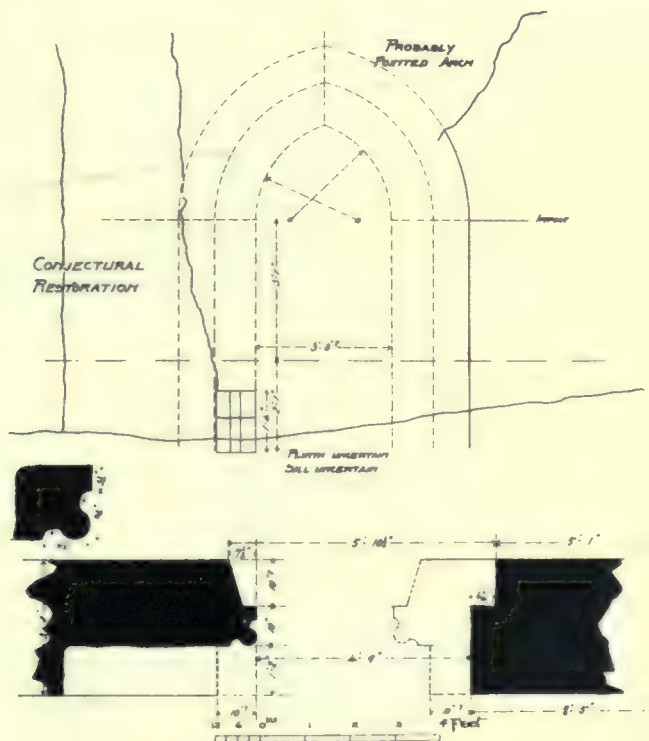
FIG. 135.--Chapel on Inch Kenneth. Details of Doorway.

The jambs (Fig. 135) and arch were of two orders. Judging by the remains of wall it had no hood and no cap. I did not make out whether it had been a pointed or a half-circular arch, as there is only a small portion of the masonry fitting the back of the outer order above the west impost remaining to judge by. Probably pointed.

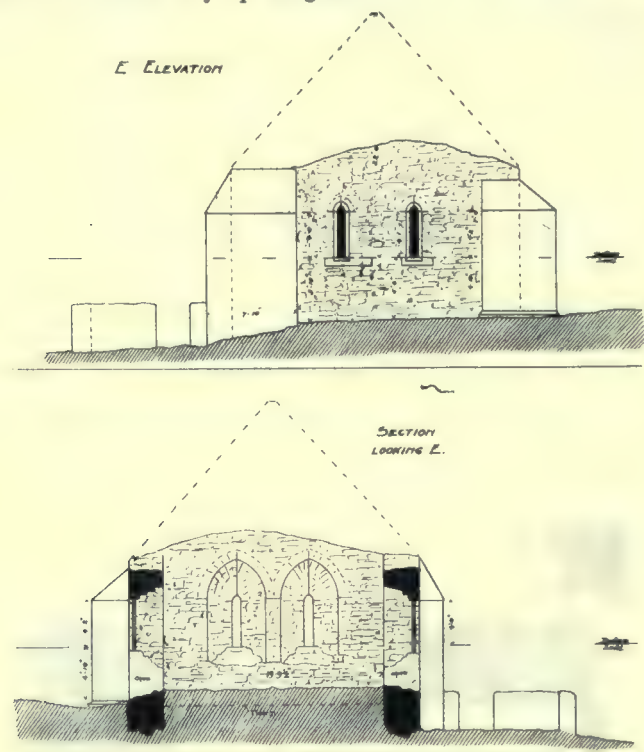
FIG. 136.—Chapel on Inch Kenneth. East End—Exterior and Interior.

The east end (Fig. 136) remains to 15 feet high, a little above the eaves. The side walls (Fig. 137) are about 12 feet high, and the west wall remains to a little way up the gable.

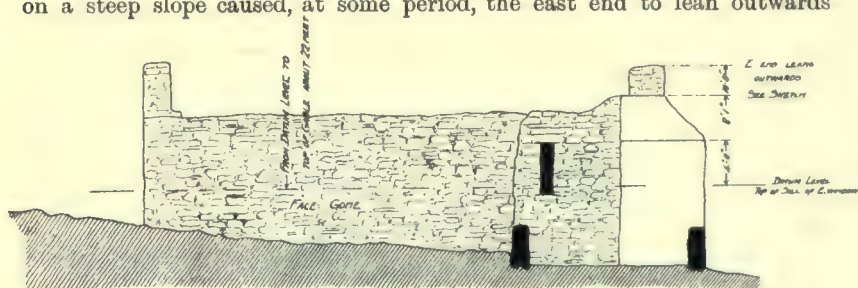
FIG. 137.—Chapel on Inch Kenneth. South Elevation.

The facing of the south wall and the south-west angle have disappeared. The weakness of foundation and the position of the east end on a steep slope caused, at some period, the east end to lean outwards

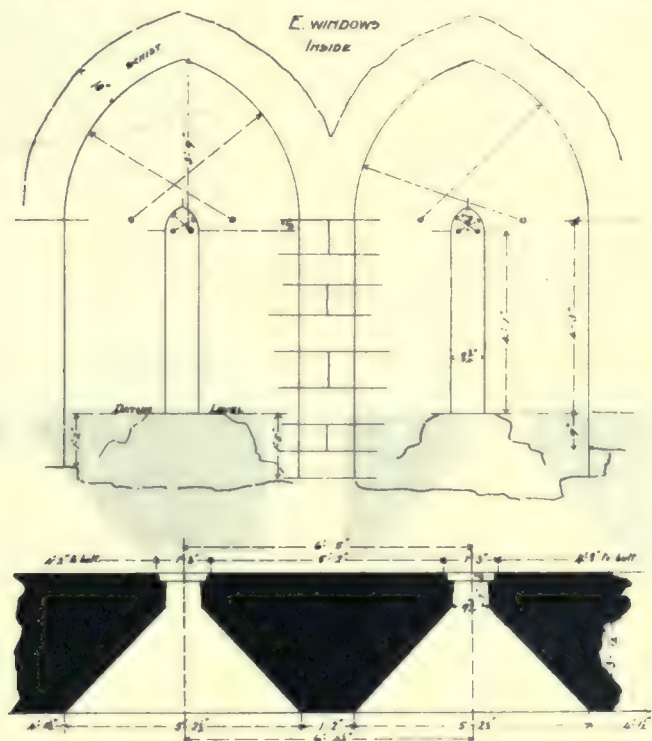
FIG. 138.—Chapel on Inch Kenneth. East Windows.

In the east end are two plain lancets (Fig. 138), 4 feet 8 inches high and  $8\frac{3}{4}$  inches wide, with wide splays to the inside.

There is no groove for glass, and so it probably was fixed in a wooden frame.

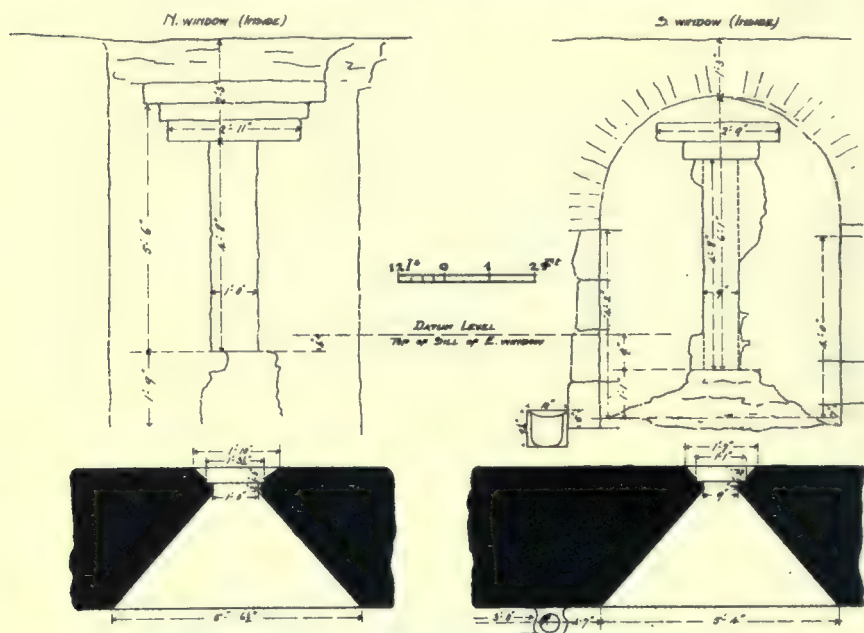
FIG. 139.—Chapel on Inch Kenneth. North and South Windows—Interior.

On the north is, near the east end, a square-headed light (Figs. 139, 140), 4 feet 8 inches by 1 foot. It has no glass groove. The internal head is not now arched, but probably was so at first.

Between this and the east wall is a projecting stone with hollow in it, but no drain. (See Fig. 139.) It is difficult to assign a date to this, but I think, probably, it is of fourteenth or fifteenth century.

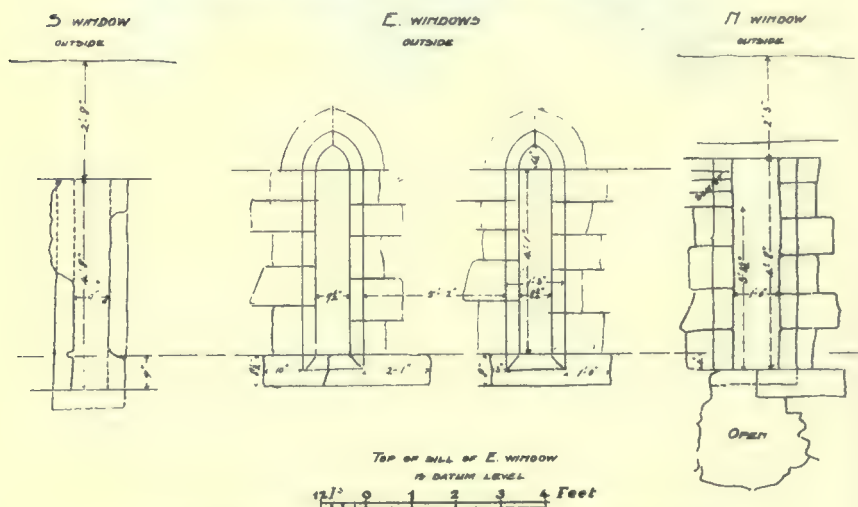
FIG. 140.—Chapel on Inch Kenneth. South-East and North Windows—Exterior.

On the south, and nearly opposite the last, is a light, 4 feet 8 inches by 9 inches, with a square head and internal arch. (See Fig. 140.)

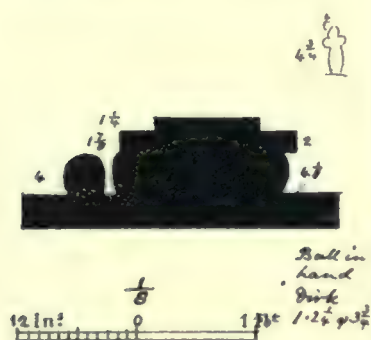
Slab  $7\cdot2\frac{1}{4} \times 2\cdot8$   
 Pillow  $11\frac{1}{2} \times 8$  4.3 relief  
 Nose  $8\frac{1}{2}$  relief  
 Face 6 wide  
 Small figures  $3\frac{1}{4}$  wide 1.5 relief  
 Target 1.6 diam  
 Shield for arms  $1\cdot0 \times 10\frac{1}{2}$

This effigy was not laid down at the spot, but sketched & measured.

It is of hard freestone.

In the burial-place on the south side of chapel is a floriated tombstone (Fig. 141), also an effigy in relief (Fig. 142). This is 6 feet 7½ inches long from the top of the cap to the heels. The figure is in relief of about 4 inches average, flattened on the upper surface, like many others in that

district, and is in the same stone as the slab, as usual. The slab is 7 feet  $2\frac{1}{4}$  inches by 2 feet 8 inches, of hard freestone. He has no metal armour except his skull-cap or morion, which has a raised longitudinal rib and a narrow brim. The head rests on a simple pillow of 3 inches relief. He wears a quilted dress reaching to the knees, and over that, apparently a

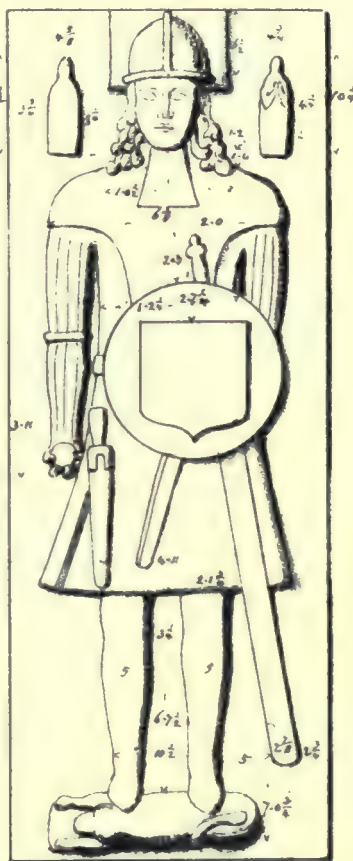
FIG. 141.

surcoat. The face has no protection; the hair is long and curly, falling over the shoulders; he has no beard and no moustache. Below the chin falls the broad end of a tie (?) of some kind. The right arm, in a quilted sleeve, is extended by the side, and in the hand is a cannon (?) ball. Lying over the waist is a circular target, 1 foot in diameter and 2 inches thick, and on this is a shield (presumably to receive the arms either in sculpture or paint) of  $10\frac{1}{2}$  inches width and  $1\frac{1}{4}$  inch thickness.

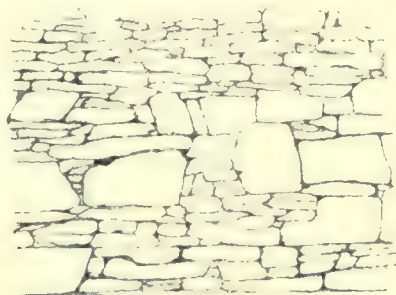
The drawing here shown is a more accurate representation of the general style of the masonry.

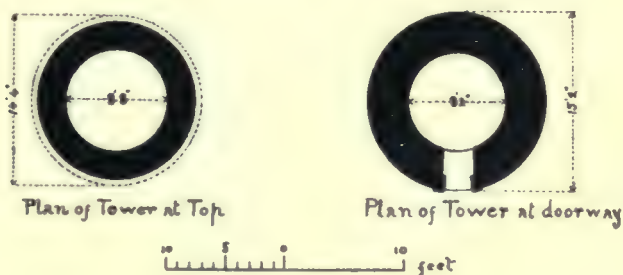
FIG. 143.—Abernethy Tower. Plans.

on the side next the latter is two or three feet deeper than that of the churchyard. The doorway (Fig. 143) is situated on the north side of the tower and within the burial-ground. It stands (Fig. 144) about 2 feet 6 inches above the ground, and has had in recent times a few steps built in front of it. The doorway has a plain fillet, 6 inches broad and projecting 2 inches, wrought on the jambs and round the circular arched head. It is 7 feet 8 inches from the sill to the crown of the arch. The jambs incline inwards, the opening being 2 feet 8 inches at the base, and 2 feet 4 inches at the spring of the arch. The round head is hollowed out of a single stone, and the thickness of the wall behind it is arched with several voussoirs. The jambs are each in two stones, which extend through the thickness of the wall. The wall is 3 feet 6 inches thick at the doorway, and the internal diameter of the tower at that level is 8 feet 2 inches.
